CLIENT: Quantum Group Importing & Distribution Ltd. 20D Kaimanawa Street Kelvin Grove Palmerstone North 4414	SAMPLE RECEIVED FROM: Quantum Group Importing & Distribution Ltd. SAMPLE DESCRIPTION: Flooring Planks – WISE Wood/WISE Cork Planks 1225x195mm assembly.	Date Received:	5.6.23
Attn.: Larry Harrison			
Client Order No.:	Client Reference:		1 of 4

ISO 4760:2022(E) - LAMINATE FLOORING – TOPICAL MOISTURE RESISTANCE – ASSEMBLED JOINT (MODIFIED)

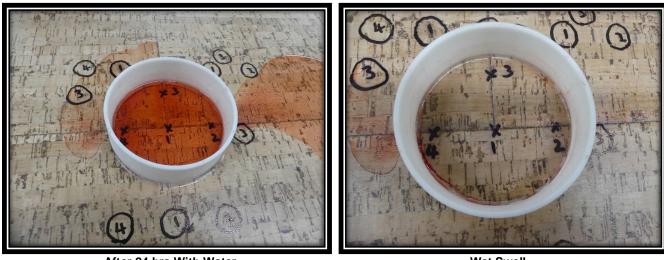
After 24 hrs With Water

Wet Swell

Recovered Swell

Recovered Swell (Disassembled)

Observations:	Specimen 1	Specimen 2	Specimen 3	
Migration of water along the upper surface:	Yes	Yes	Yes	
Migration of water to the underside:	No	No	No

Disassembly Observations:	Specimen 1	Specimen 2	Specimen 3
Migration of water along the upper surface:	Yes	Yes	Yes
Migration of water to the underside:	No	No	No
